# Uniform Mitigation Verification Inspection Form

Inspection Date: 2025-01-13		
<b>Owner Information</b>		
Owner Name:		Contact Person:
Address: (400 - 416) Bristle Cone Ln		Home Phone:
City: Naples	Zip: 34113	Work Phone:
County: Collier		Cell Phone:
Insurance Company:		Policy #:
Year of Home: 1976	# of Stories: 2	Email:

# Wind Mitigation Photos

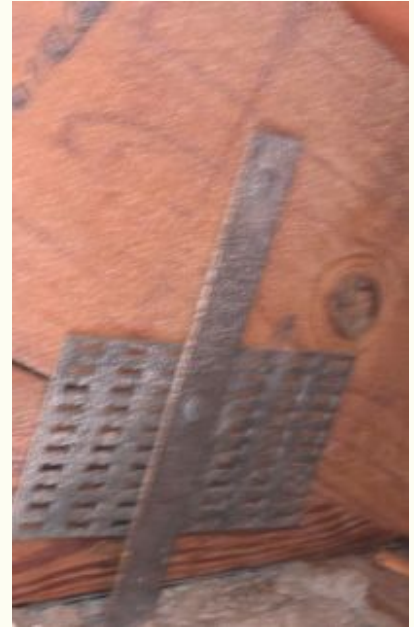
**Roof to Wall Attachment (#RWA)**

- ☒ A. Toe Nails
  - ☐ Truss/rafter anchored to top plate of wall using nails driven at an angle through the truss/rafter and attached to the top plate of the wall, or
  - ☒ Metal connectors that do not meet the minimal conditions or requirements of B, C, or D

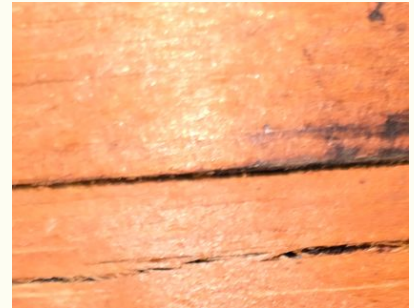
**Secondary Water Resistance(#SWR)**

- ☐ A. SWR (also called Sealed Roof Deck) Self-adhering polymer modified-bitumen roofing underlayment applied directly to the sheathing or foam adhesive SWR barrier (not foamed-on insulation) applied as a supplemental means to protect the dwelling from water intrusion in the event of roof covering loss.
- ☐ B. No SWR.
- ☒ C. Unknown or undetermined.

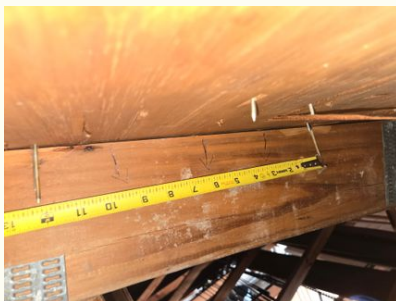
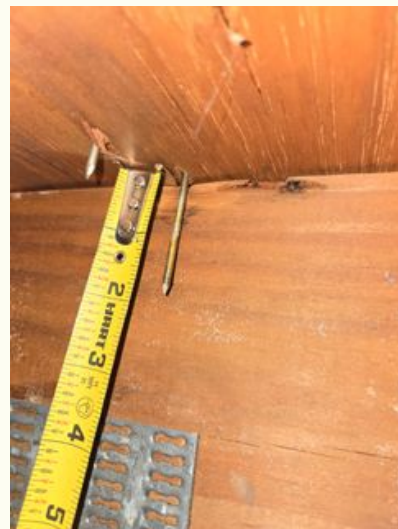
✦ Inspection Notes: **ROOF DECK ATTACHMENT (#RDA)**

- ☒ C. Plywood/OSB roof sheathing with a minimum thickness of 7/16" inch attached to the roof truss/rafter (spaced a maximum of 24" inches o.c.) by 8d common nails spaced a maximum of 6" inches in the field. -OR- Dimensional lumber/Tongue & Groove decking with a minimum of 2 nails per board (or 1 nail per board if each board is equal to or less than 6 inches in width). -OR- Any system of screws, nails, adhesives, other deck fastening system or truss/rafter spacing that is shown to have an equivalent

or greater resistance than 8d common nails spaced a maximum of 6 inches in the field or has a mean uplift resistance of at least 182 psf.
