Uniform Mitigation Verification Inspection Form

Inspection Date: 2025-01-13		
Owner Information		
Owner Name:		Contact Person:
Address: (406-526) Bristle Cone Ln		Home Phone:
City: Naples	Zip: 34113	Work Phone:
County: Collier		Cell Phone:
Insurance Company:		Policy #:
Year of Home: 1976	# of Stories: 2	Email:

Wind Mitigation Photos

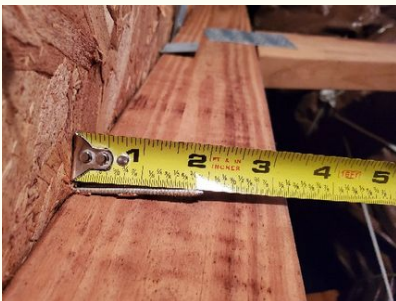
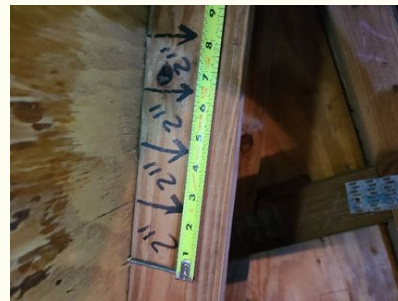
📌 Inspection Notes: **Roof to Wall Attachment (#RWA)**

- ☒ A. Toe Nails
 - ☐ Truss/rafter anchored to top plate of wall using nails driven at an angle through the truss/rafter and attached to the top plate of the wall, or
 - ☒ Metal connectors that do not meet the minimal conditions or requirements of B, C, or D
