# Uniform Mitigation Verification Inspection Form

Inspection Date: 2025-01-13		
<b>Owner Information</b>		
Owner Name:		Contact Person:
Address: (418-438) Bristle Cone Ln		Home Phone:
City: Naples	Zip: 34113	Work Phone:
County: Collier		Cell Phone:
Insurance Company:		Policy #:
Year of Home: 1976	# of Stories: 2	Email:

# Wind Mitigation Photos

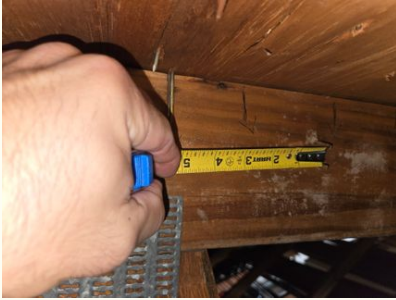
### 📌 Inspection Notes: **ROOF DECK ATTACHMENT (#RDA)**

- ☒ C. Plywood/OSB roof sheathing with a minimum thickness of 7/16" inch attached to the roof truss/rafter (spaced a maximum of 24" inches o.c.) by 8d common nails spaced a maximum of 6" inches in the field. -OR- Dimensional lumber/Tongue & Groove decking with a minimum of 2 nails per board (or 1 nail per board if each board is equal to or less than 6 inches in width). -OR- Any system of screws, nails, adhesives, other deck fastening system or truss/rafter spacing that is shown to have an equivalent

or greater resistance than 8d common nails spaced a maximum of 6 inches in the field or has a mean uplift resistance of at least 182 psf.

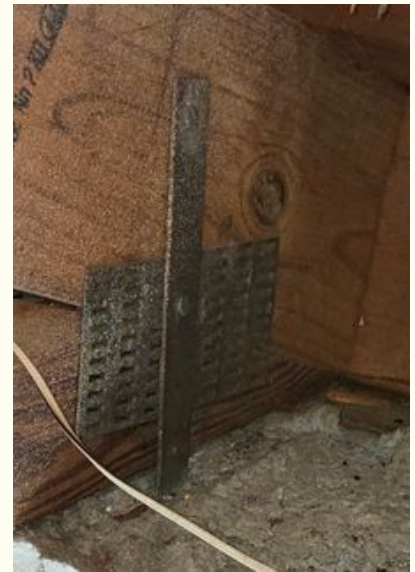
### 📌 Inspection Notes: **Roof to Wall Attachment (#RWA)**

- ☒ A. Toe Nails
  - ☐ Truss/rafter anchored to top plate of wall using nails driven at an angle through the truss/rafter and attached to the top plate of the wall, or
  - ☒ Metal connectors that do not meet the minimal conditions or requirements of B, C, or D
