# Uniform Mitigation Verification Inspection Form

Inspection Date: 2025-01-13		
<b>Owner Information</b>		
Owner Name:		Contact Person:
Address: 440-460 Bristle Cone Ln		Home Phone:
City: Naples	Zip: 34113	Work Phone:
County: Collier		Cell Phone:
Insurance Company:		Policy #:
Year of Home: 1976	# of Stories: 1	Email:

# Wind Mitigation Photos

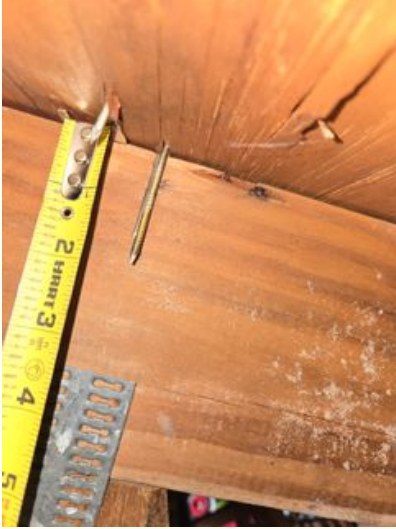
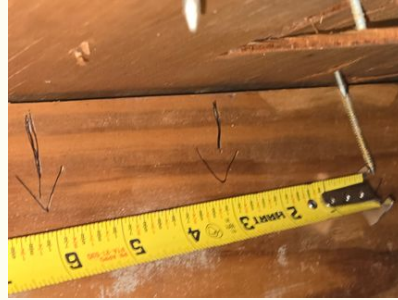
📌 Inspection Notes: **ROOF DECK ATTACHMENT (#RDA)**

- ☒ C. Plywood/OSB roof sheathing with a minimum thickness of 7/16" inch attached to the roof truss/rafter (spaced a maximum of 24" inches o.c.) by 8d common nails spaced a maximum of 6" inches in the field. -OR- Dimensional lumber/Tongue & Groove decking with a minimum of 2 nails per board (or 1 nail per board if each board is equal to or less than 6 inches in width). -OR- Any system of screws, nails, adhesives, other deck fastening system or truss/rafter spacing that is shown to have an equivalent

or greater resistance than 8d common nails spaced a maximum of 6 inches in the field or has a mean uplift resistance of at least 182 psf.

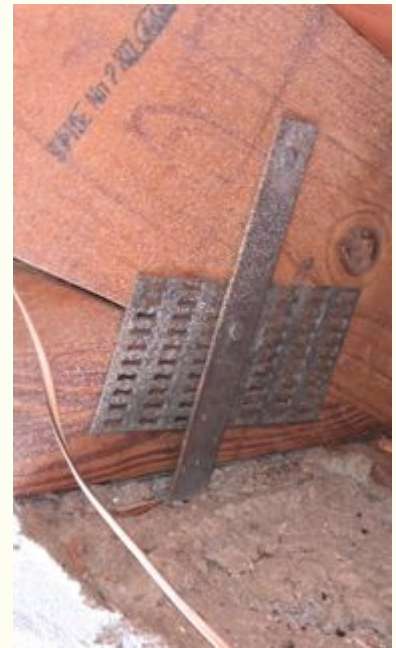
📌 Inspection Notes:  
**Roof to Wall Attachment (#RWA)**

- ☒ A. Toe Nails
  - ☐ Truss/rafter anchored to top plate of wall using nails driven at an angle through the truss/rafter and attached to the top plate of the wall, or
  - ☒ Metal connectors that do not meet the minimal conditions or requirements of B, C, or D
