Uniform Mitigation Verification Inspection Form

Inspection Date: 2025-01-13		
Owner Information		
Owner Name:		Contact Person:
Address: 462-482 Bristle Cone Ln		Home Phone:
City: Naples	Zip: 34113	Work Phone:
County:		Cell Phone:
Insurance Company:		Policy #:
Year of Home: 1976	# of Stories: 2	Email:

Wind Mitigation Photos

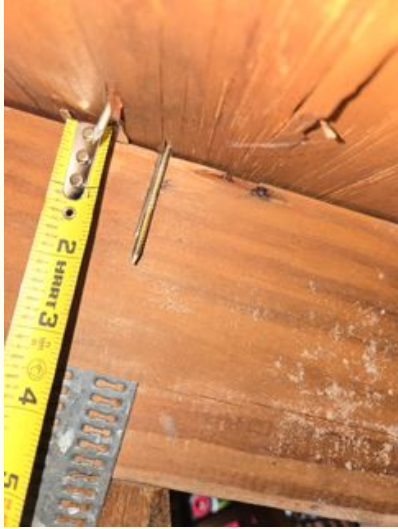
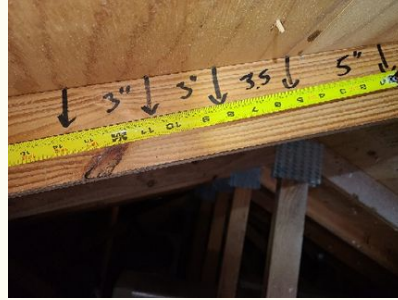
📌 Inspection Notes: **ROOF DECK ATTACHMENT (#RDA)**

- ☒ C. Plywood/OSB roof sheathing with a minimum thickness of 7/16" inch attached to the roof truss/rafter (spaced a maximum of 24" inches o.c.) by 8d common nails spaced a maximum of 6" inches in the field. -OR- Dimensional lumber/Tongue & Groove decking with a minimum of 2 nails per board (or 1 nail per board if each board is equal to or less than 6 inches in width). -OR- Any system of screws, nails, adhesives, other deck fastening system or truss/rafter spacing that is shown to have an equivalent

or greater resistance than 8d common nails spaced a maximum of 6 inches in the field or has a mean uplift resistance of at least 182 psf.

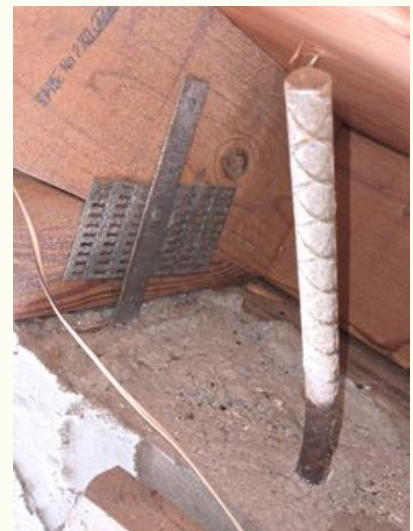
📌 Inspection Notes: **Roof to Wall Attachment (#RWA)**

- ☒ A. Toe Nails
 - ☐ Truss/rafter anchored to top plate of wall using nails driven at an angle through the truss/rafter and attached to the top plate of the wall, or
 - ☒ Metal connectors that do not meet the minimal conditions or requirements of B, C, or D
