Uniform Mitigation Verification Inspection Form

Inspection Date: 2025-01-13		
Owner Information		
Owner Name:		Contact Person:
Address: 528 Bristle Cone Ln		Home Phone:
City: Naples	Zip: 34113	Work Phone:
County: Collier		Cell Phone:
Insurance Company:		Policy #:
Year of Home: 1976	# of Stories: 1	Email:

Wind Mitigation Photos

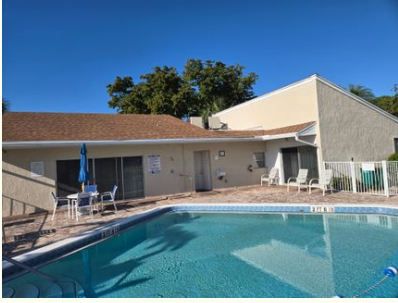
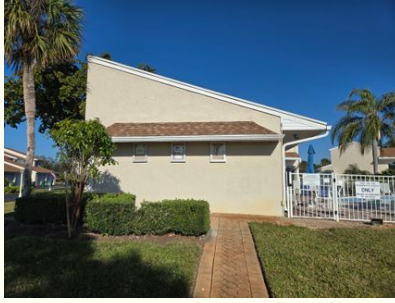
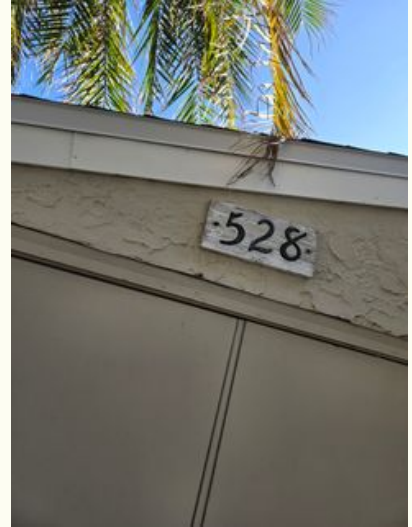
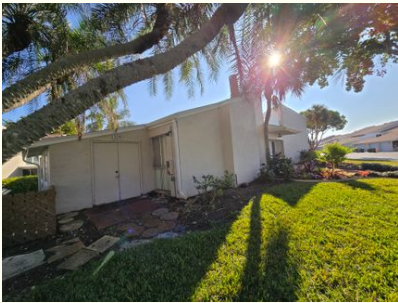
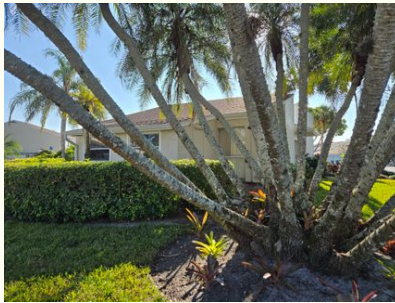
📌 Inspection Notes: **Roof Geometry(#RG)**

5. **Roof Geometry:** What is the roof shape? (Do not consider roofs of porches or carports that are attached only to the fascia or wall of the host structure over unenclosed space in the determination of roof perimeter or roof area for roof geometry classification).

- ☐ A. Hip Roof Hip roof with no other roof shapes greater than 10% of the total roof system perimeter.
Total length of non-hip features: _____ feet; Total roof system perimeter: _____ feet
- ☐ B. Flat Roof Roof on a building with 5 or more units where at least 90% of the main roof area has a roof slope of less than 2:12. Roof area with slope less than 2:12 _____ sq ft; Total roof area _____ sq ft
- ☒ C. Other Roof Any roof that does not qualify as either (A) or (B) above.

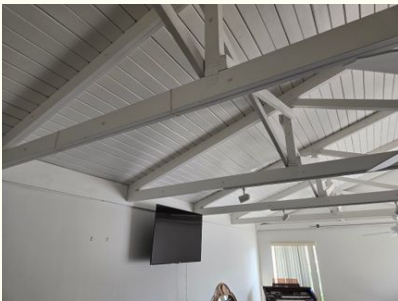
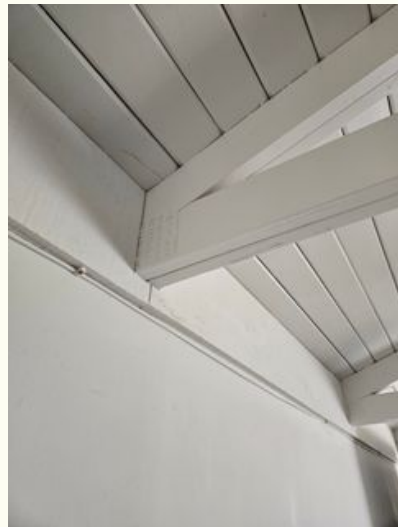
📌 Inspection Notes: **Roof to Wall Attachment (#RWA)**

4. **Roof to Wall Attachment:** What is the **WEAKEST** roof to wall connection? (Do not include attachment of hip/valley jacks within 5 feet of the inside or outside corner of the roof in determination of WEAKEST type)

- ☒ A. Toe Nails
 - ☒ Truss/rafter anchored to top plate of wall using nails driven at an angle through the truss/rafter and attached to the top plate of the wall, or
 - ☐ Metal connectors that do not meet the minimal conditions or requirements of B, C, or D

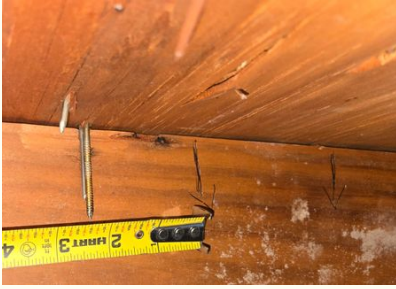
✧ Inspection Notes: **ROOF DECK ATTACHMENT (#RDA)**

3. **Roof Deck Attachment:** What is the weakest form of roof deck attachment?
 - ☐ A. Plywood/Oriented strand board (OSB) roof sheathing attached to the roof truss/rafter (spaced a maximum of 24" inches o.c.) by staples or 6d nails spaced at 6" along the edge and 12" in the field. -OR- Batten decking supporting wood shakes or wood shingles. -OR- Any system of screws, nails, adhesives, other deck fastening system or truss/rafter spacing that has an equivalent mean uplift less than that required for Options B or C below.

- ☒ C. Plywood/OSB roof sheathing with a minimum thickness of 7/16" inch attached to the roof truss/rafter (spaced a maximum of 24" inches o.c.) by 8d common nails spaced a maximum of 6" inches in the field. -OR- Dimensional lumber/Tongue & Groove decking with a minimum of 2 nails per board (or 1 nail per board if each board is equal to or less than 6 inches in width). -OR- Any system of screws, nails, adhesives, other deck fastening system or truss/rafter spacing that is shown to have an equivalent

or greater resistance than 8d common nails spaced a maximum of 6 inches in the field or has a mean uplift resistance of at least 182 psf.
